CASE REPORT

Observation of retrieved ceramic-on-ceramic articular surface: a case of revised total hip arthroplasty due to failure of the support ring

Received: January 26, 2004 / Accepted: September 3, 2004

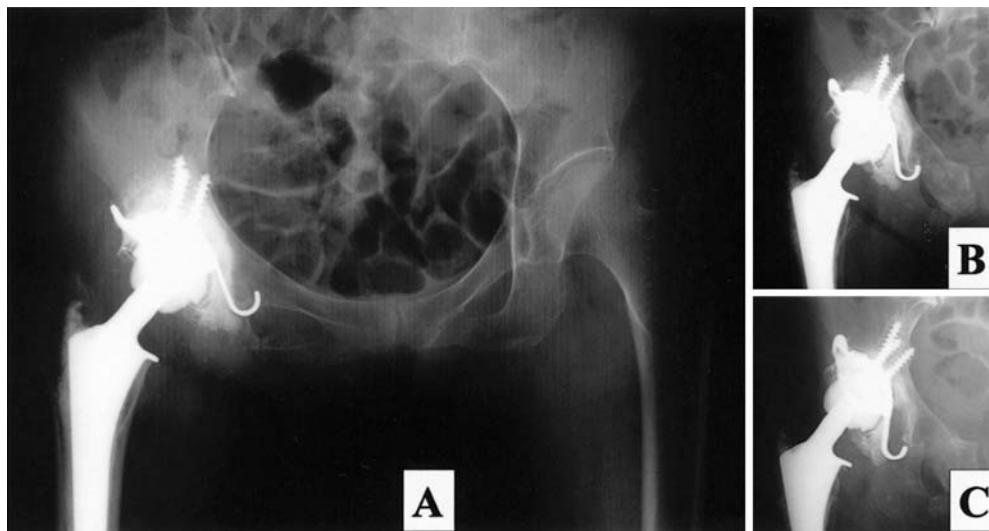
The patient was a 63-year-old woman with rheumatoid arthritis. In April 1998, using a Ganz ring (Protek, Bern, Switzerland), cemented THA was performed with an alumina-bearing surface (ABS) cup and alumina head manufactured by Kyocera (Kyoto, Japan). The angle of the cup placement was 45° and the postoperative result was satisfactory. However, 7 months after the operation the patient fell, fracturing both sides of the pubic bone and ischium, causing the ring to detach. She was able to walk indoors steadily, and the ceramic cup was fixed with a support ring in a cement well. The angle of the cup placement just after injury was 56°. Thereafter, the cup placement angle gradually became acute and reached 62°, so revision surgery was performed on January 2000, 1 year 2 months after the support ring had become detached (Fig. 1).

Fig. 1A–C. Course shown by X-ray films. **A** After primary operation; the angle of the cup placement is 45°. **B** After fracturing, both sides of the pubic bone and ischium cause the hook to come off; the angle of the cup placement is 56°. **C** Before revision surgery; the angle of the cup placement is 62°.

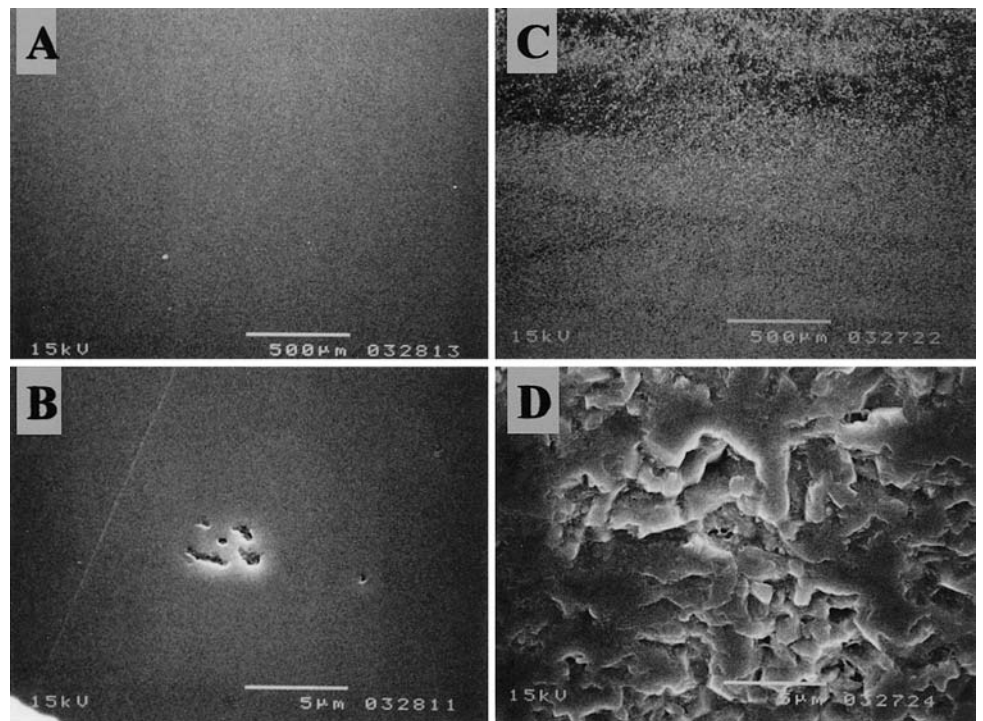
Macroscopically, the gloss was lost or appeared as matte in an area of about 10 × 4 mm, 53° from the equator part toward the top of the head. The gloss remained on the cup but a black line was found near the rim.

Scanning electronic microscopy observations showed an extremely smooth image at the top part and the equator part of the head at low magnification, while at high magnification the usual void and scratch traces were observed at one part of the equator. No particular trace of damage was found in either of these parts. However, the matte part of the head had a gritty rough surface at low magnification, and at high magnification most of the areas had recesses on the smooth surface and an angular crystal grain image. The crystal grain removal is thought to be due to some kind of contact (Fig. 2). Furthermore, the sphere bottom part and the central portion of the side surface of the cup were extremely smooth at low magnification, while at high magnification voids and scratches were observed but nonetheless had the usual satisfactory sliding surface. Regarding the end portion of the side surface part of the cup (the edge and not the sliding surface), in section 1 of the side surface part, only grain removal and unclear scratches were observed at high magnification. These were thought to be the remains of abrasion traces from manufacture (Fig. 3). However, at the edges of sections 2 and 3 of the side surface, a strip of white was seen at low magnification and at high magnification, intensive grain removal similar to that on the matte part of

Fig. 2A–D. Scanning electronic microscopy observations (head). **A** Equator 3 (low magnification). Smooth image. **B** Equator 3 (high magnification). Voids and scratches are recognized but no trace of damage is apparent. **C** Matte part (low magnification). Gritty rough surface. **D** Matte part (high magnification). Image of angular crystal grain, and grain removal

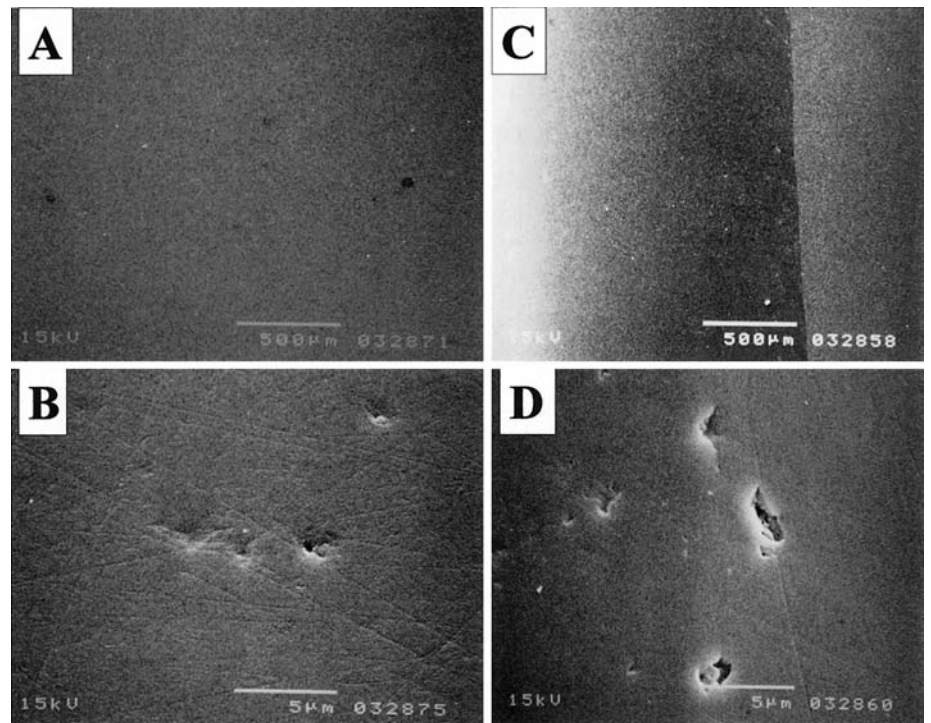
Fig. 3A–D. Scanning electronic microscopy observations (sphere bottom of the cup and end portion of the side surface of the cup, section 1). **A** Sphere bottom (low magnification). Smooth image. **B** Sphere bottom part (high magnification). Voids and scratches are recognized but there is no trace of damage. **C** End portion of section 1 of side surface (low magnification). Streaks thought to be abrasive traces are recognized. **D** End portion of section 1 of the side surface part (high magnification). Grain removal and unclear scratches are recognized

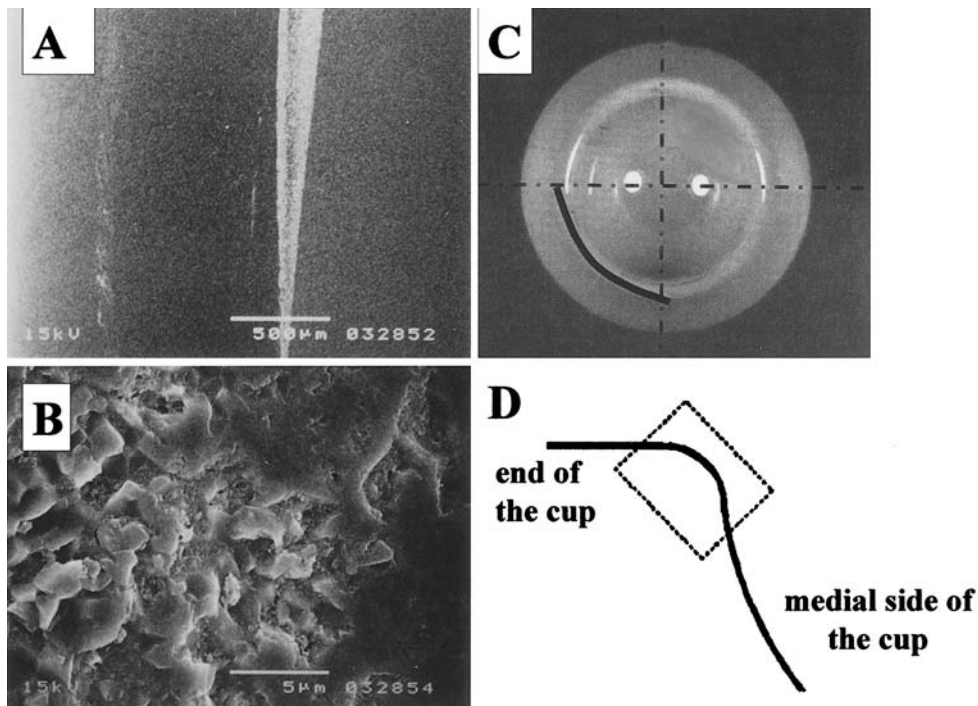
the head was observed. As the surface condition matched that of the matte part of the head, we considered that this condition was caused by contact with the matte part of the head (Fig. 4).

age or revision, and all are working well up to now. Although no dislocation was found in the present case, clear abrasion was recognized at the edges of the cup and not on the sliding surface. Even if we cannot prove when such changes happened, this suggests the possibility that when

Fig. 4A–D. Scanning electronic microscopy observations (end portion of the side surface of the cup, section 3). **A** A strip of white is recognized at low magnification. **B** Intensive grain removal is recognized at high magnification. **C** Removed cup. *Dotted line* is the wire-positioning part, *thick solid line* is the damage from section 2 to section 3 of the side surface. **D** Observation field outline of the cup: *dotted line* is the end portion of the side surface

occurs but also at the edges (pistoning⁷). It is not known under what kind of placement conditions this phenomenon occurs, but abrasion and damage to the ceramic may result from intensive contact at the edges, especially in ceramic-on-ceramic THA, therefore measures to deal with such problems must be considered further.
