## Phase transformation of a new generation yttria-stabilized zirconia femoral head after total hip arthroplasty

**Abstract** We examined a new-generation yttria-stabilized zirconia head manufactured by NGK 1 year after total hip arthroplasty. Monoclinic content of the retrieved head was twice that of the unused head at the pole and equator. A fourfold increase in monoclinic content was observed at 5 mm below the equator. Transformation from the tetragonal phase to the monoclinic phase occurred in the new generation zirconia with alumina doping within a relatively short period in vivo.

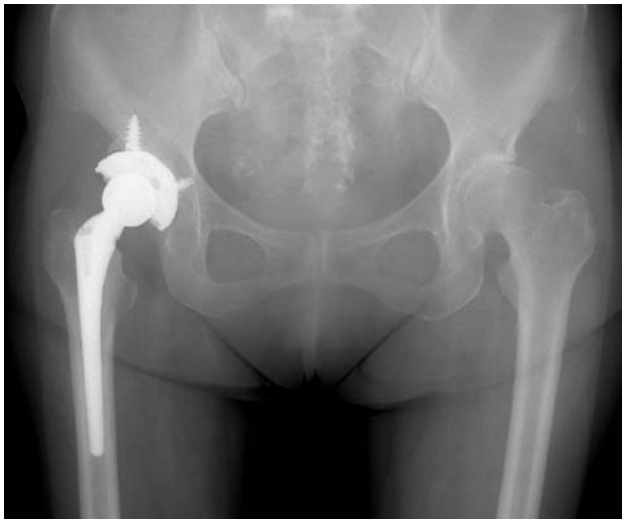
**Fig. 1** Anteroposterior radiography of the hip showing stable fixation of a cementless total hip implant after six dislocations

Postoperatively, the patient experienced pain relief and could walk without a cane, but developed dislocation six times within 1 year and was referred to us. Anteroposterior radiography of the hip showed that both cup and stem were fixed to bone without radiolucent lines (Fig. 1). Cup orientation was  $41^\circ$  of abduction and  $3^\circ$  of anteversion in the radiographic definition [6]. On physical examination with fluoroscopic imaging, the femoral head subluxed with the hip in  $90^\circ$  of flexion and  $20^\circ$  of internal rotation. In 2002, we revised the implants to a metal-on-metal large-diameter femoral head bearing (Birmingham system; MMT, Birmingham, England) through a posterior approach (Fig. 2). The top of the elevated liner was found to have been directed laterally, and the prosthetic neck impingement on the elevated rim was observed at  $90^\circ$  of flexion and  $20^\circ$  of internal rotation. The Trident titanium alloy cup was well fixed to the acetabulum, and the cup was chiseled out. After 1 mm under reaming of the acetabulum, a Birmingham HA coated cobalt-chrome cup of 48 mm outer diameter was impacted in the acetabulum with a press-fit technique. The Super Securefit stem was removed, and a cobalt chrome stem was fixed with cement with a 42-mm Birmingham modular cobalt-chrome head. Then, no impingement of the prosthesis or instability was intraoperatively seen at  $90^\circ$  of flexion and  $60^\circ$  of internal rotation. As of 5 years after revision, no dislocations have occurred.

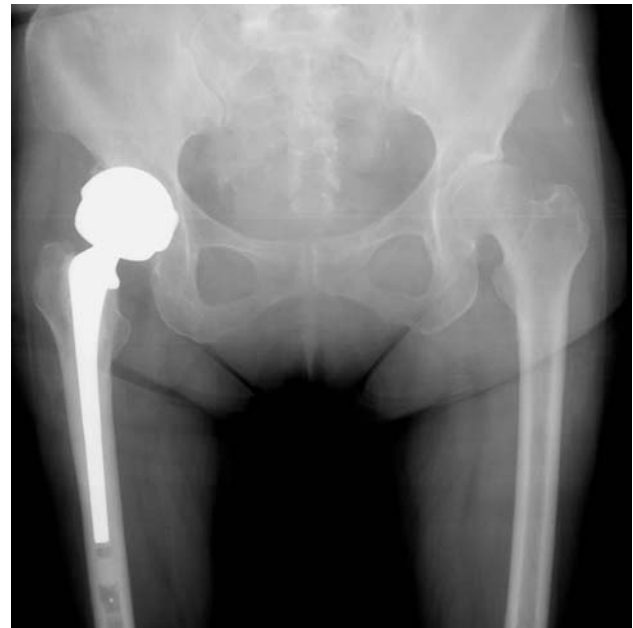
**Fig. 2** Anteroposterior radiography of the hip after revision using a metal-on-metal large-diameter bearing
